Water Quality Evaluation of Spring Waters in Nsukka, Nigeria

Special Publication of the Nigerian Association of Hydrological Sciences, 2012

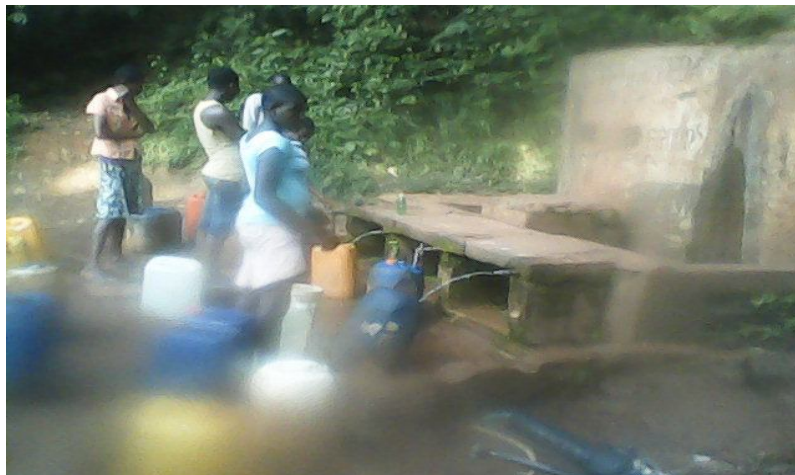
Asho spring is located at the foot of the hills at Onuiyi layout area of Nsukka, with the hills as the source of the water. The Asho spring water is well built and channeled to concrete reservoirs, where outlets were made through taps for collection as shown in (Figure 3). The water is only seen at the outlets because it runs underground but with very poor or no maintenance at all. The spring is a major source of water for the people of Onuiyi, especially during the dry season. Sanitary inspections of the surroundings revealed human defecation at the upper part of the hills, which is a source of biological pollutant. There are also land developments since the top of the hill is a table land.

Figure 3: Water collection at the Asho spring, Nsukka, Nigeria

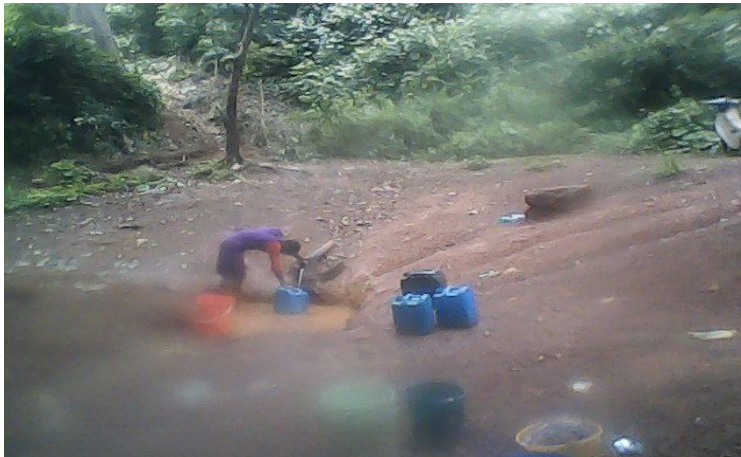
Ajie spring source has almost the same features as Asho with a refuse dump site at the entrance of the spring source. It is located at Odenigbo area of Nsukka, behind Erina Hotels. Like Asho spring, it a major source of water supply for the inhabitants of Odenigbo. Ajie spring is also well built but the reservoirs are dilapidated and are out of use. The spring water is collected at the point where the reservoir pipe is broken as shown below in Figure 4.

Figure 4: Ajie spring in Odenigbo, Nsukka, Nigeria.

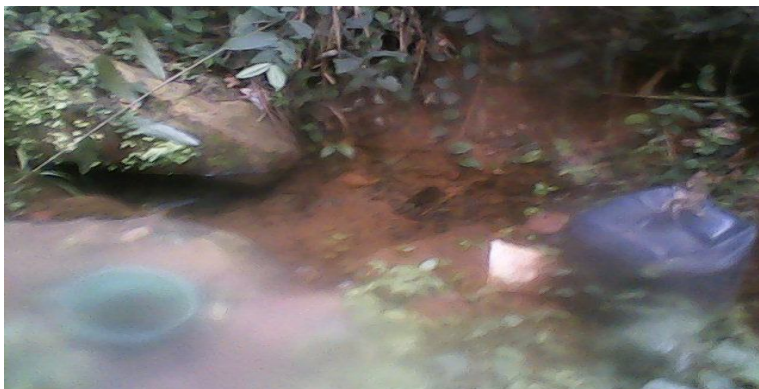
Iyi-Nsukka spring is located at the foot of the hills behind the timber shade in Nsukka. The spring is not well built but drains from the stone and ponds in a small open earthen depression from where water is scooped with a cup or bowl as seen in (Figure 5).

Figure 5: Iyi-Nsukka spring, Nsukka, Nigeria

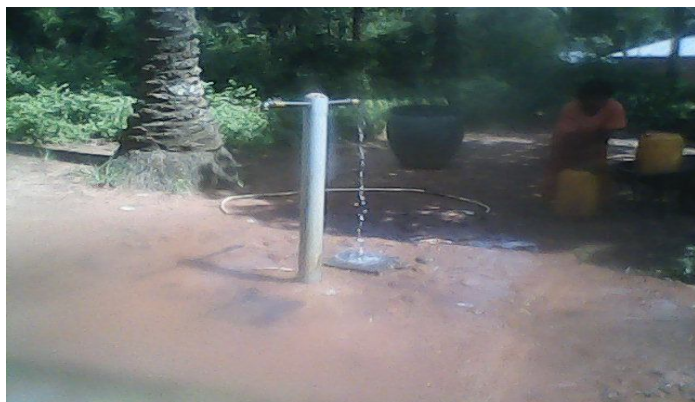
Ikwoka-Obimo spring is located at Ikwoka village, Obimo in Nsukka. It is located in the village but, its source is at the foot of a hill few kilometers away. The spring is well built and channeled to the center of the village for domestic purposes as shown in (Figure 6).

Figure 6: Ikwoka-Obimo spring, Obimo, Nsukka, Nigeria
