Analysis of Selected Failed Gully Erosion Control Works in Imo State

Amangabara G. T.

Dept of Environmental Technology, Flood and Erosion Control Unit, School of Environmental Technology
Federal University of Technology, Owerri, Nigeria.

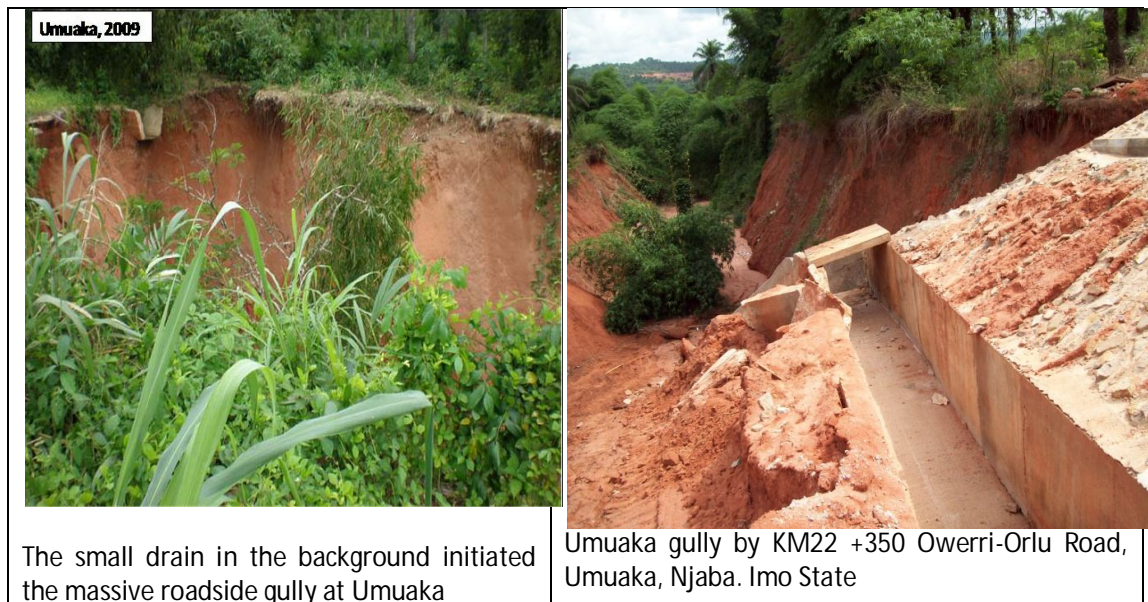
In this area, there are a network of gullies with average depth of 50 m, width of 80 m and length of 2000 m respectively. The gullies mainly originated from poorly constructed side drains and termination of culvert at unsafe points at the Njaba River valley along the Owerri – Orlu road (Figure 2). The gullies originate as narrow rills with a down-slope orientation, which undergo progressive widening and deepening, with successive rainfall events. The poorly terminated drain generated a waterfall effect on the poorly consolidated sandstones and cohesionless soil which resulted in the gully erosion. A good knowledge of surface hydrology would have prevented this scenario by determining the effective runoff and properly designing an effective drain that can accommodate the volume and velocity of runoff generated in the Njaba watershed.

Figure 2: Umuaka Gully

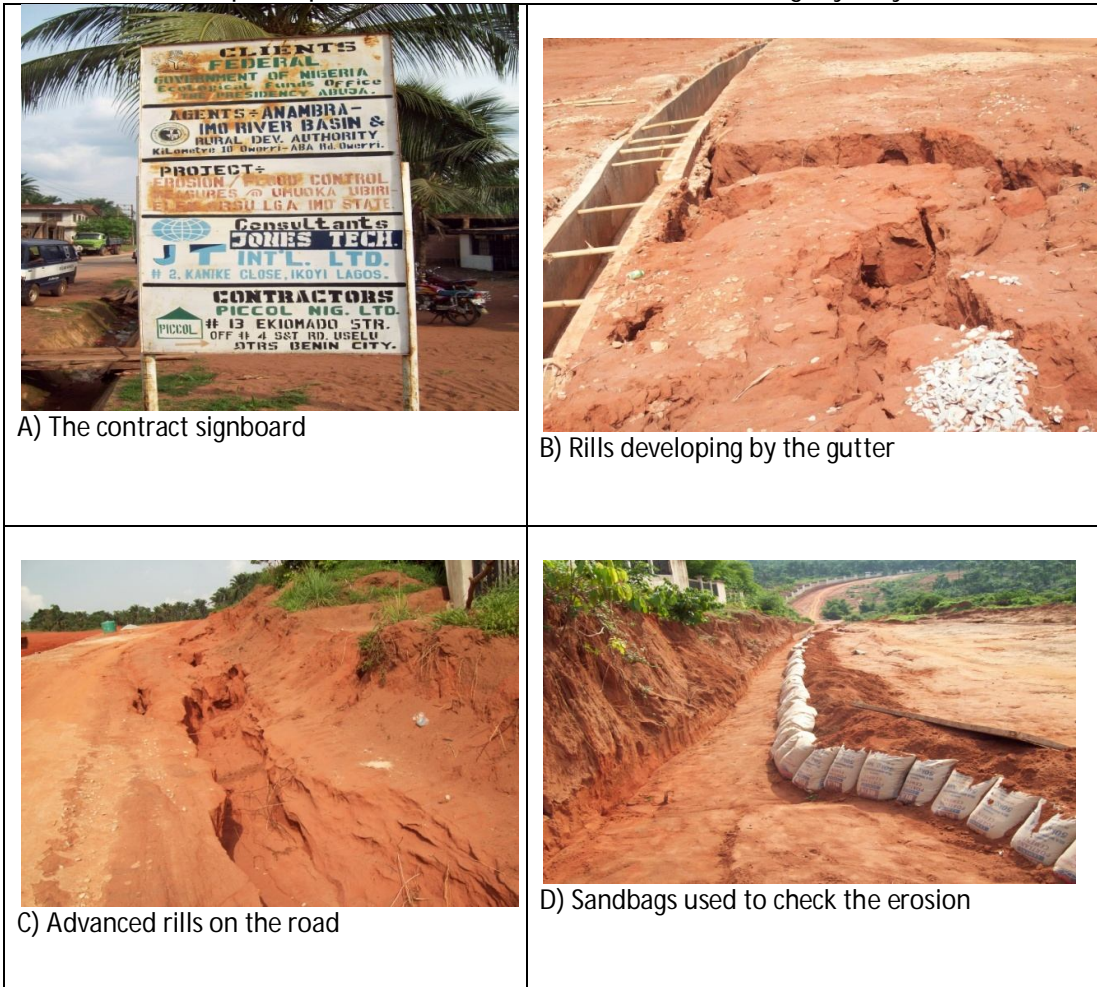
The gully in this site was mechanically bulldozed and flattened out down to the Azezie Asa river. Due to poor work done in terms of soil compaction and defective concrete channel (drainage length - 900m, depth - 1m, width-1m, thickness of concrete - 0.15m, no rip-rap, no groin, no armoury, no detention) rills have begun to develop measuring up to 700 m in length and 1.4 m in depth. Current effort at checking this erosion is the use of sandbags (Figure 3). The power of surface runoff was completely disregarded in this site. In no time, if urgent efforts are not put in place to control the surface runoff, the gully may resurface.

Figure 3: Umuoka Ubiri Elem erosion site

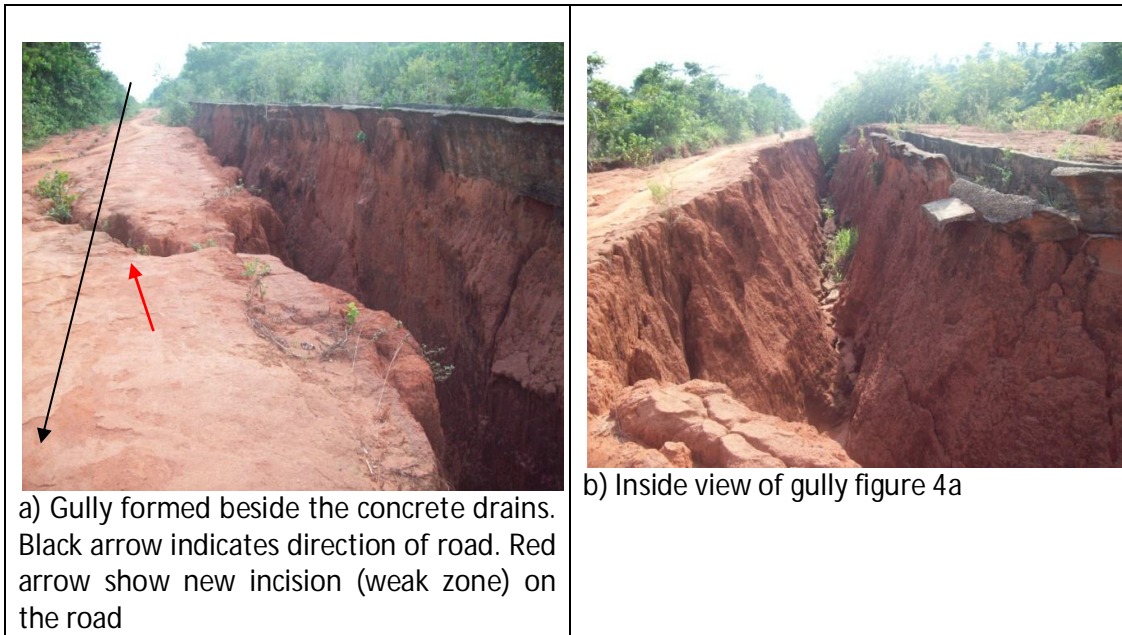
This gully was initiated from failed culvert on the earth road linking Avu in Mbanjo LGA. The length of the slope, and perhaps long duration and intensive rainfall initiated sheet erosion as a result of the loose soil in the area. As the sheet erosion occurs, the walls of the gutter (concrete drains) besides the earth became exposed and gradually collapsed, forming rill which later develop on weak zones to form three major gullies dissecting the entire slope into series of small rills forming a badland topography (Figure 4). We have reason to believe

that, at the design stage, the effective runoff for this watershed vis-à-vis the slope was not considered.

Figure 4: Ikeduru gully

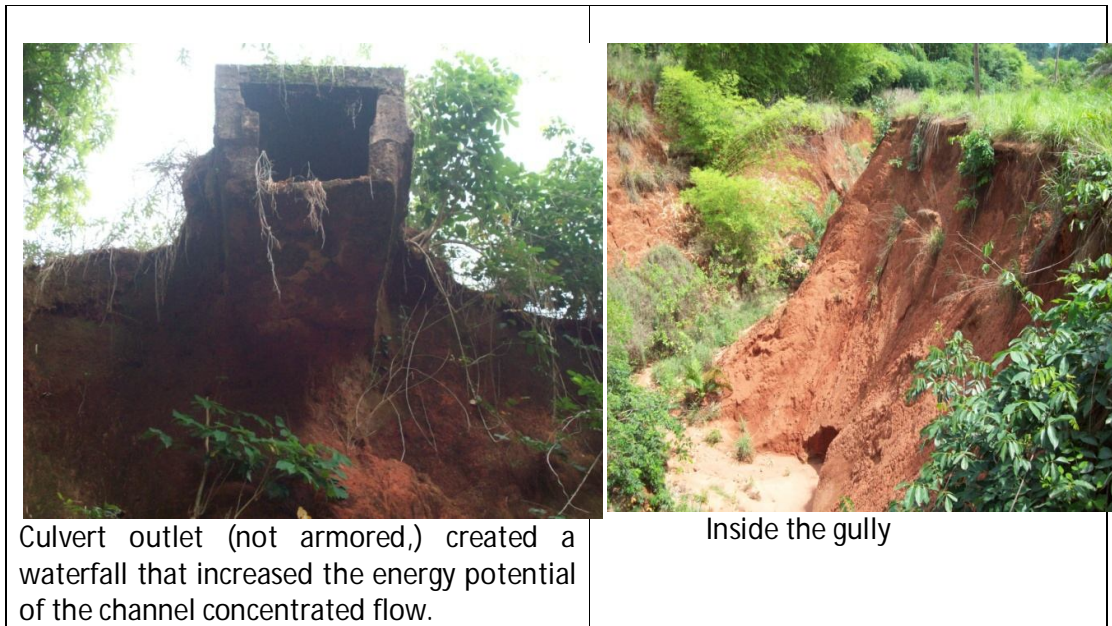
This gully started sometime in the 1990s at the outlet of the earth road from the Ogberuru main town to the maternity, and continued to a nearby village called Uhuala. The earth road from Ogberuru town to the maternity has a badly constructed side drain that has increased the erosivity of the water flowing through it. Since the culvert outlet was not armored, the erosion at the invert of the culvert created a waterfall that increased the energy potential of the channel concentrated flow. The gully receives its water from all the surrounding villages of Ubaha and Ogberuru communities.

Figure 5: Ogberuru gully formed by drainage
